PAVEMENT EVALUATION REPORT

NOVEMBER 2021

Prepared For:
City of Ashford
P.O. Box 428
Ashford, Alabama 36312

Prepared By:
CDG Engineers & Assoc, Inc.
1840 East Three Notch Street
Andalusia, Alabama 36421

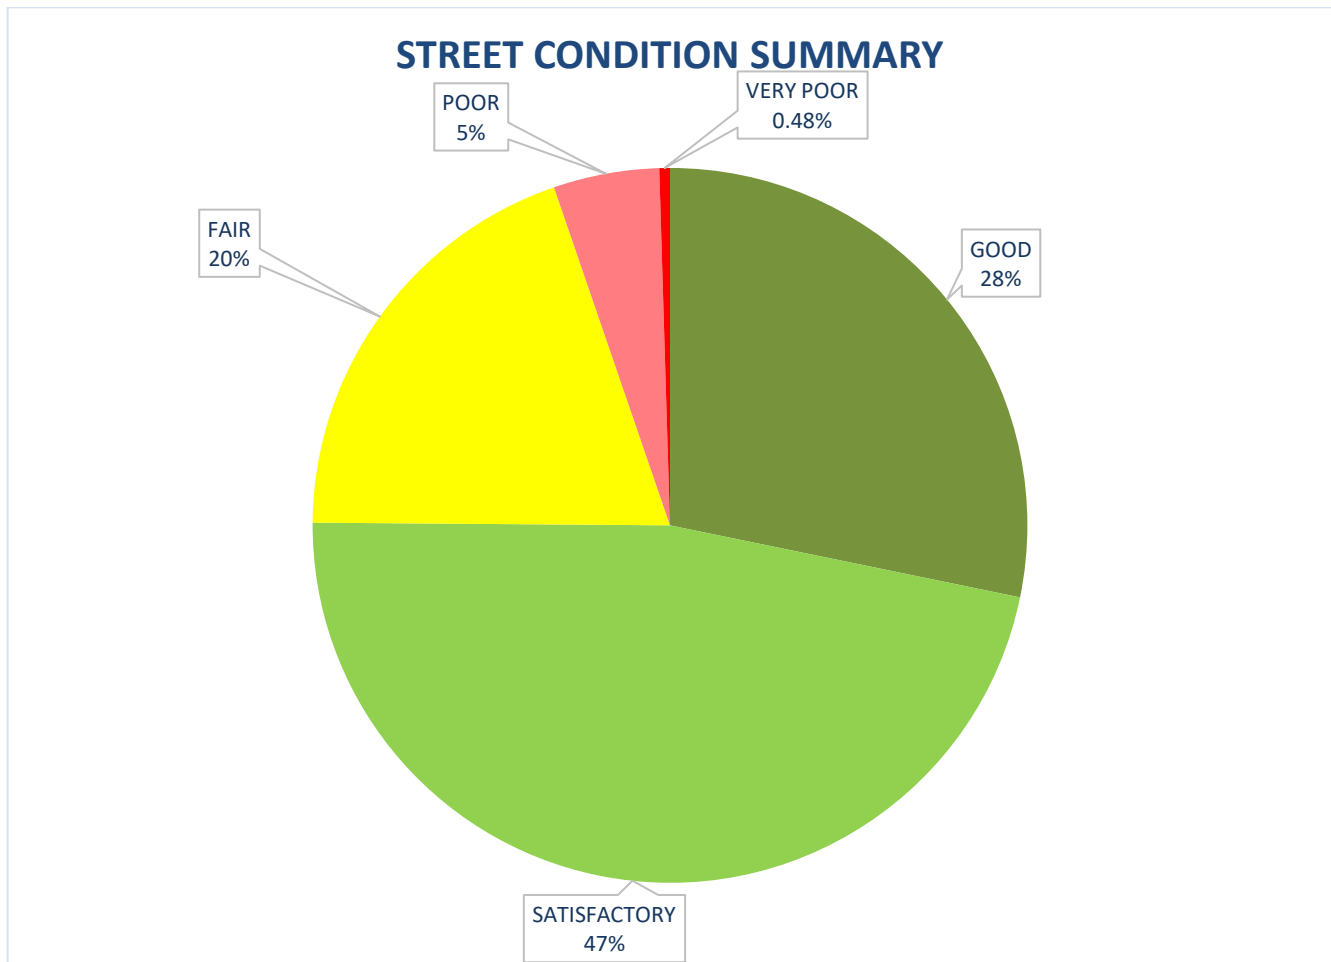
Figure 1: Street Condition Summary

As shown in Figure 1 above, the majority of roads within the City of Ashford (75%) had PCR values of 70 or higher and were categorized as “satisfactory” (47%) or “good” condition (28%). Less than 1 percent of the City’s roadways had PCRs under 40, categorized as “very poor”. No roadways categorized as “serious” or “failed”. The remaining roadways were considered to be in “fair” (20%) or “poor” (5%) condition. ***The average PCR for all roads within the limits of the City of Ashford is 76.6, which is rated as “Satisfactory” according to the established PCR scale.***

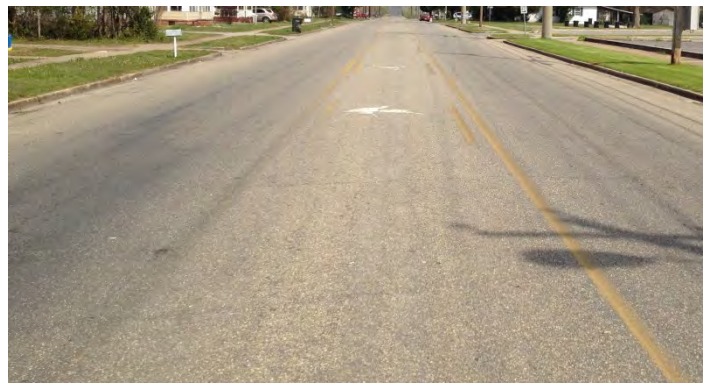
BLEEDING

Bleeding is defined as a film of asphalt binder on the pavement surface that causes a loss of skid resistance. Shiny, glass-like surfaces in the area of the wheel path are often typical indications of bleeding.

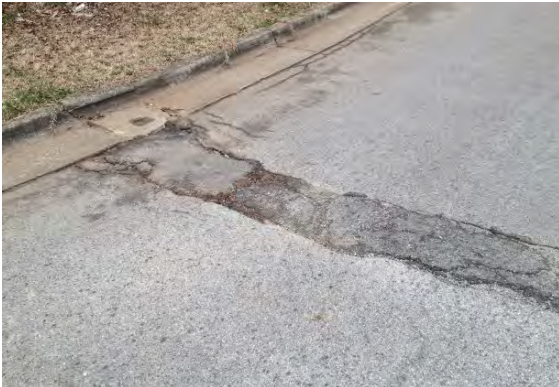
PATCHING

Patching is the placement of a new material in an effort to rehabilitate an existing pavement that has deteriorated or suffered from utility cuts.

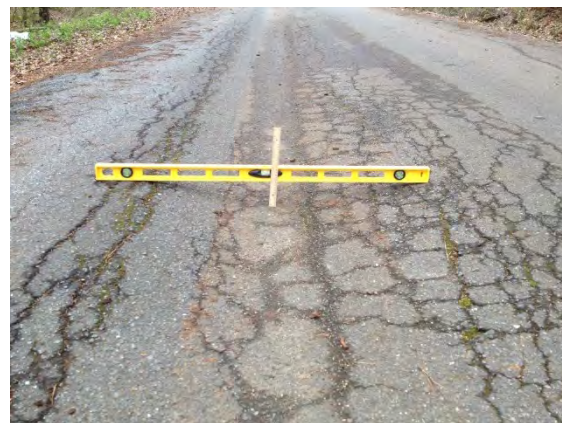
RUTTING

Rutting is a longitudinal surface depression in the wheel path. Rutting is caused by heavy loads, subgrade settlement, poor construction methods, or asphalt mixtures of inadequate strength.

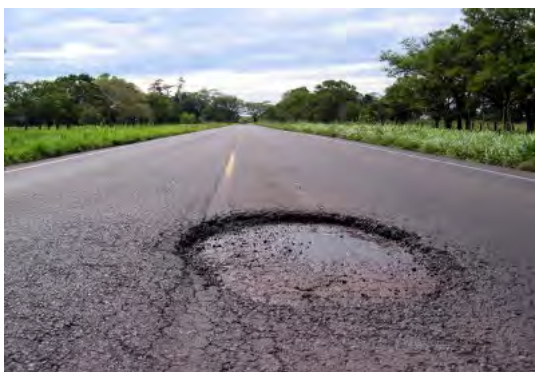
POTHOLES

Potholes are simply depressions in the pavement surface that penetrate all the way through the asphalt layer down to the base course. They allow moisture infiltration which can accelerate deterioration, and are generally the end result of alligator cracking.

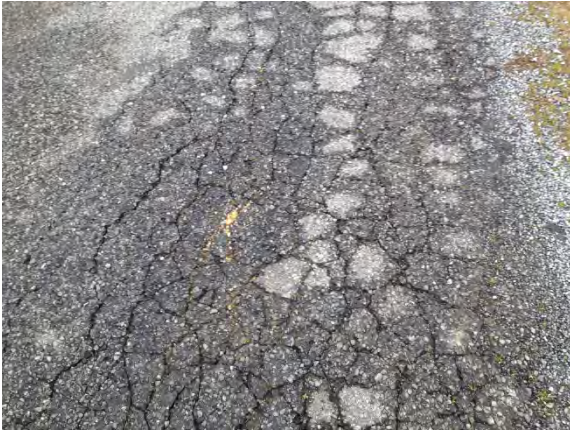
CRACKING

Fatigue (Alligator) Cracking is a series of interconnected cracks caused by fatigue failure of the asphalt surface under repeated traffic loading. It is an indicator of structural failure and the cracks allow moisture infiltration which can accelerate deterioration. Common causes of alligator cracking include loss of base/subbase material, excessive loading, inadequate structural design, and poor drainage.

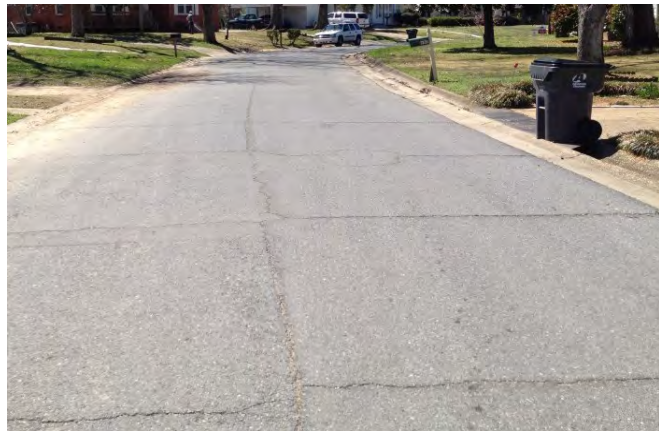
Block and Transverse Cracking is a series of interconnected cracks that divide the pavement into a series of rectangular sections. It allows moisture infiltration which can accelerate deterioration. Common causes of block cracking include shrinkage of asphalt as a result of fluctuations in daily temperatures, poor asphalt binder that is unable to expand and contract with changes in temperature, or reflection cracking from an underlying layer.

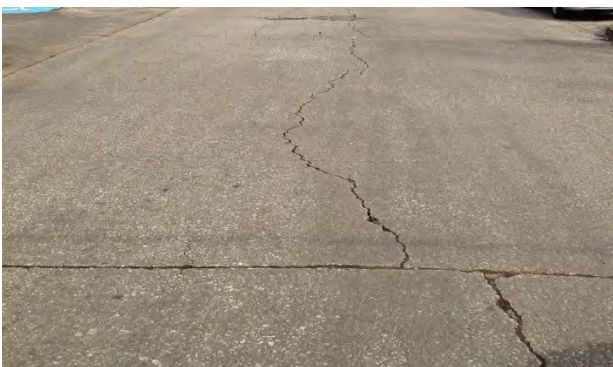
Longitudinal Cracking is cracking parallel to the centerline of the roadway with possible causes including poor construction methods, freeze/thaw cycles, daily temperature cycling, or reflection cracking. Longitudinal cracking allows moisture infiltration which can accelerate deterioration. Longitudinal cracking occurs in concrete and asphalt pavements.

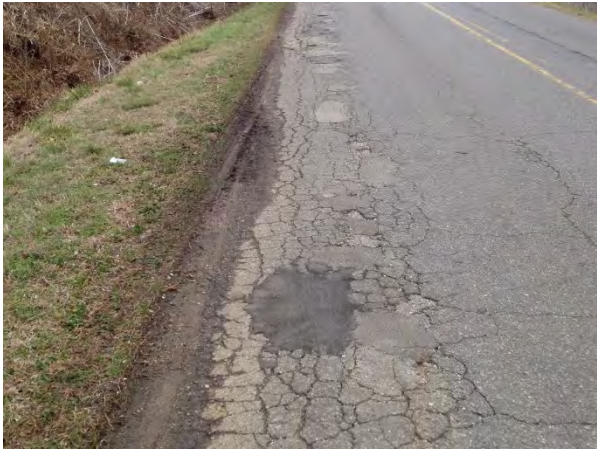
Edge Cracking is often crescent-shaped cracks or fairly continuous cracks which intersect the pavement edge. Causes of edge cracking are lack of shoulder support, insufficient quality or thickness of asphalt, or poor drainage. Edge cracking occurs in asphalt and concrete pavements.

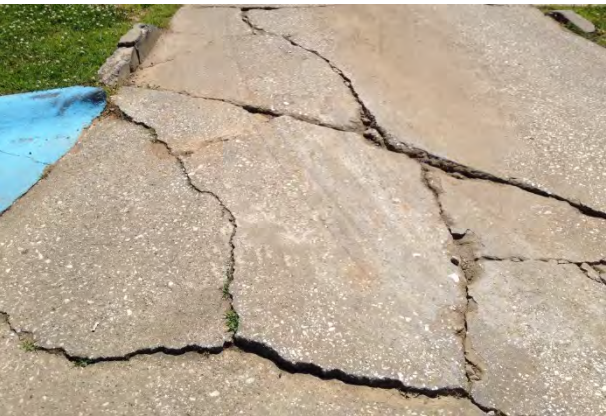
PUMPING

Pumping is movement of material underneath the slab or ejection of material from underneath the slab. Caused by water accumulation under the slab due to poor drainage, panel cracks or poor joint seals. Pumping occurs in concrete pavements.

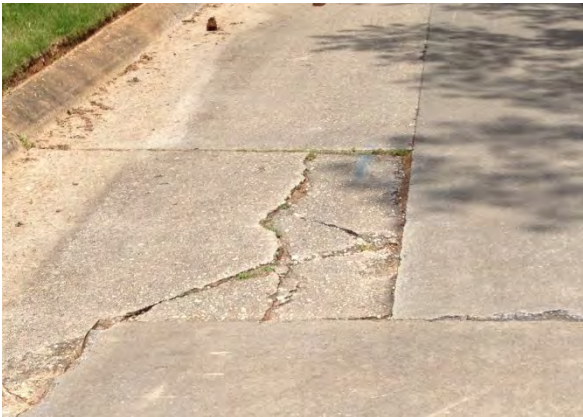
CORNER BREAKS

Corner breaks are cracks which intersect the slab joints near the corner – generally within 6’ feet of the corner- in concrete pavement. Causes of corner breaks are lack of slab support and load repetition.

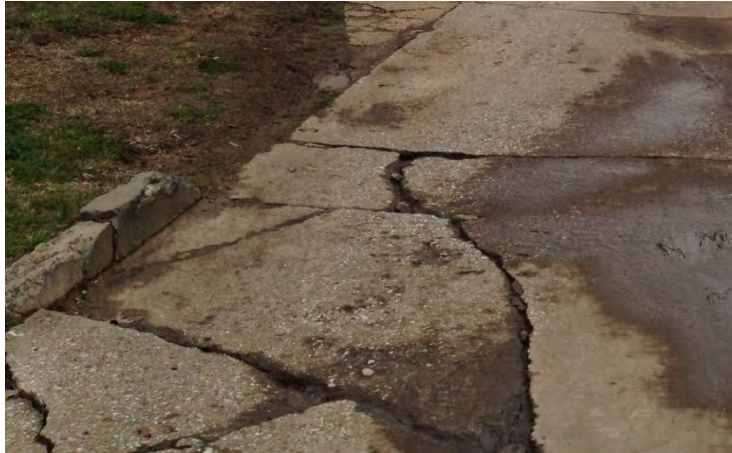
FAULTING

Faulting is a difference in elevation across a crack or joint in concrete pavement. The cause of faulting is generally pumping.

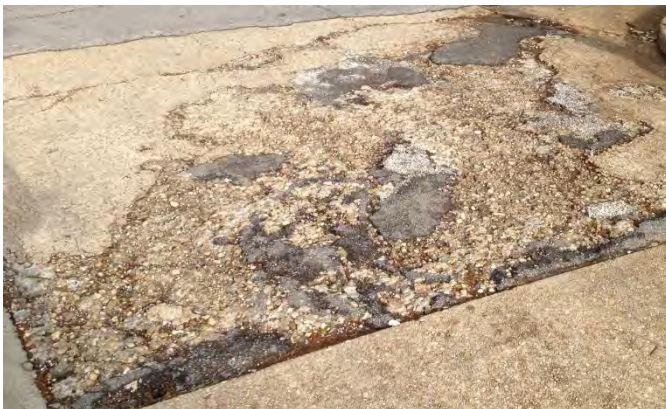
SURFACE DETERIORATION

Surface Deterioration is often the wearing away of the surface mortar and exposure of the coarse aggregate in concrete pavement. The primary cause of surface deterioration is freeze/thaw cycles.

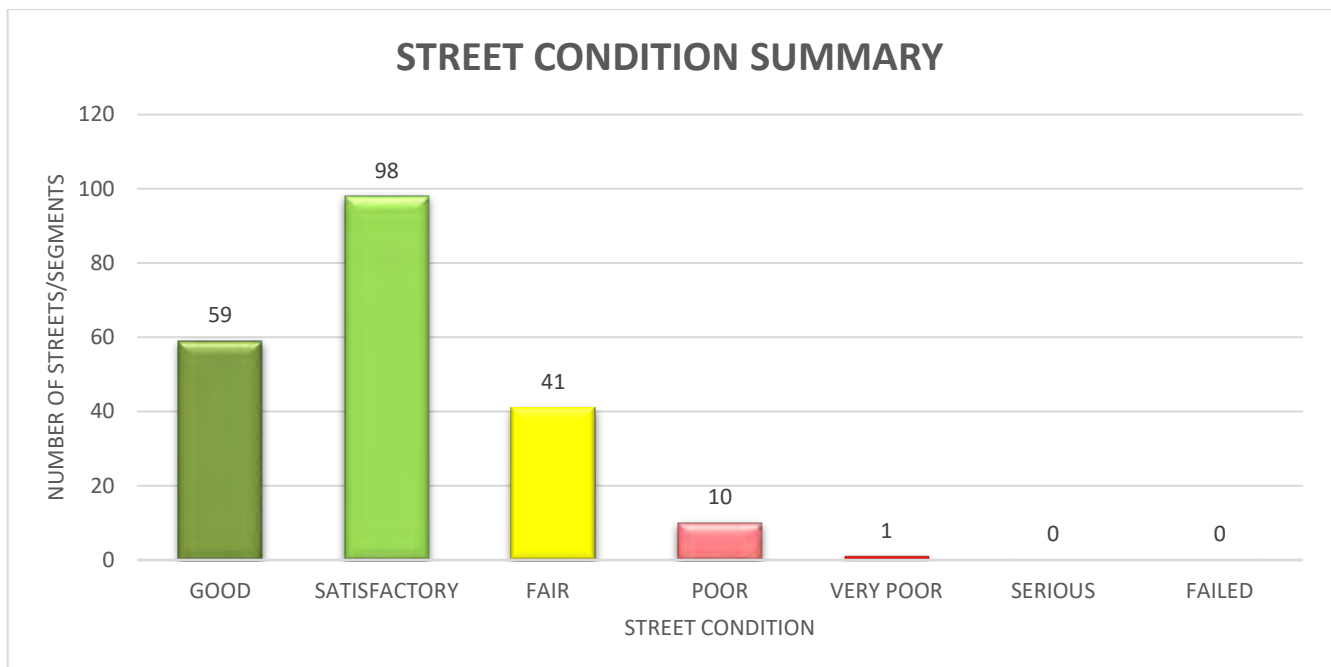
Figure 3: Street Condition Summary (City Maintained)

The City of Ashford maintains approximately 18 linear miles of roads. **The average PCR for all roads maintained by the City of Ashford is 76.6, which is rated as “Satisfactory” according to the established PCR scale.** During the evaluation, a wide range of conditions were encountered with the minimum and maximum PCR for all roads found to be 33.3 and 100, respectively.

As shown in Figure 3, below, the majority of roadways maintained by Ashford (75%) are rated “good” or “satisfactory”. These streets are best served through routine and preventative maintenance. The next largest category of roads is “fair” with 41 streets/segments (20%). These roadways are candidates for thin to moderate overlays with some localized patching. Figure 3 also shows that 10 streets (5%) are ranked as “poor”. These roadways are candidates for progressively thicker overlays with some patching. Only 1 (approximately 0.48%) fall into the “very poor” category. This roadway is heavily distressed and is showing signs of base failures. Therefore, a thick overlay with base stabilization is recommended for this street. No roadways were categorized as “serious” or “failed”.
